## **Freeze-up, breakup, and winter ice observations on four small regulated and unregulated streams in Newfoundland, Canada**

Although winter ice processes are well documented in large, low-gradient rivers, only a few studies on smaller, steeper streams have been published, and none compare regulated environments to unregulated ones. This paper documents the ice conditions observed on two regulated and two unregulated, wadeable streams in south-central Newfoundland from October 2010 to May 2011. Ice conditions were observed using 16 remote camera stations at eight salmonid spawning sites along West Salmon River, Twillick Brook, Compensation Creek, and another unnamed creek. The West Salmon River and Compensation Creek are both regulated streams, while Twillick Brook and the unnamed creek were chosen as potential (unregulated) reference sites.

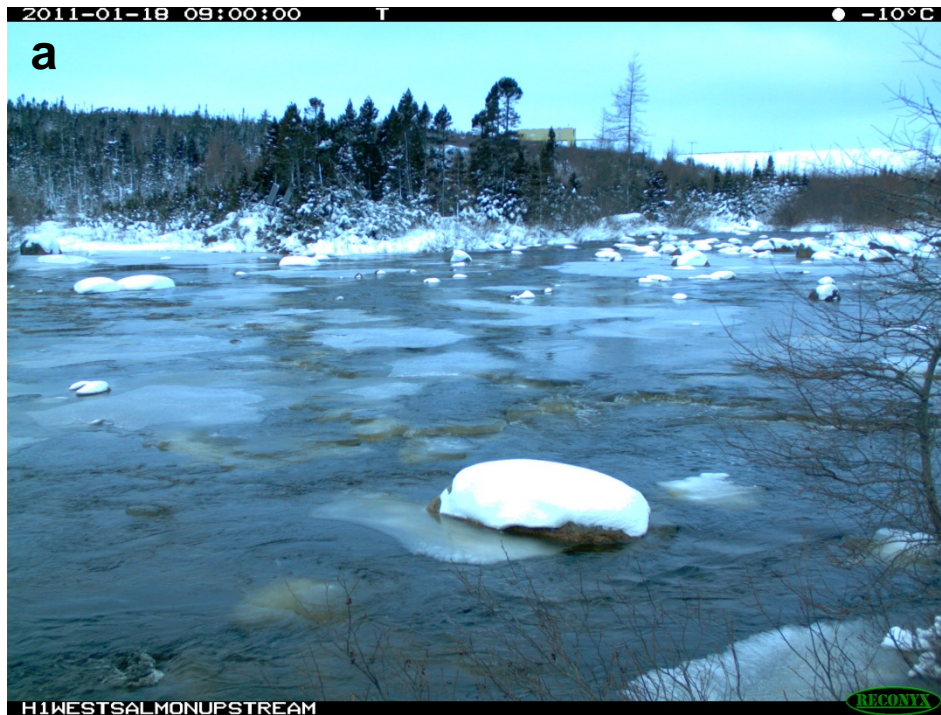
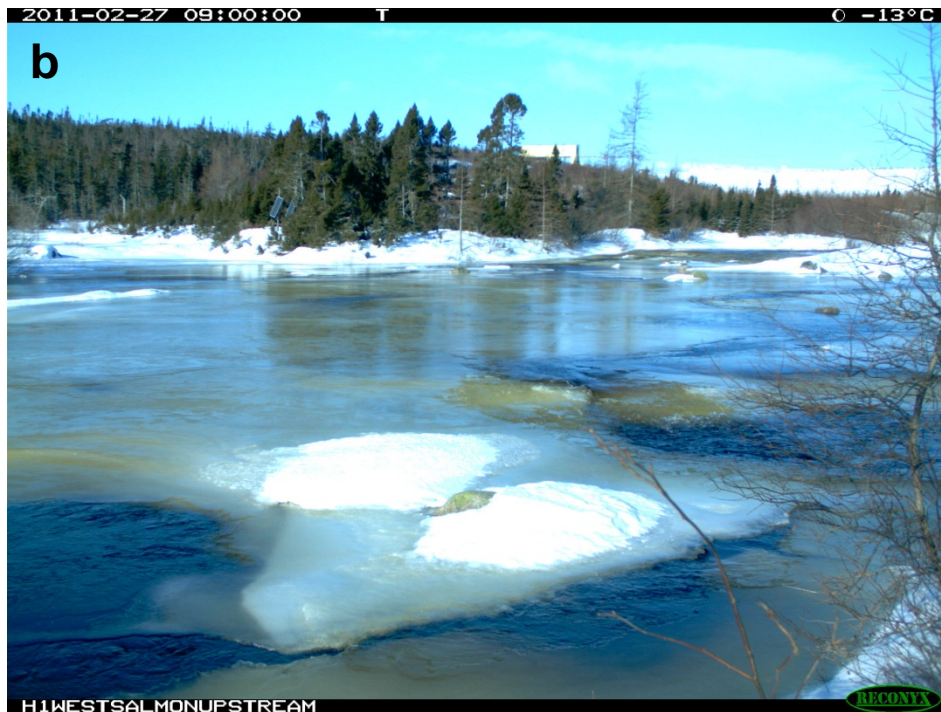
Figure 7. Ice observation photographs from the West Salmon River (regulated) upstream site taken by camera H1 showing: a) anchor ice formation on 18-Jan-11; and b) ice inundated by high water levels on 27-Feb-11.

The upstream study site on the West Salmon River was a wide (~30 to 60 m), shallow reach with many emergent boulders. As Figure 6 illustrates, freeze-up was initiated overnight on 17/18-Jan when mean daily air temperatures dropped to -7°C and water temperatures reached ~0°C. Anchor ice formed adjacent to emergent boulders and on the stream bed (Figure 7a) and was accompanied by a rise in water level. As the air temperature rose to -1.8°C on 20-Jan the water level dropped and the anchor ice diminished. Anchor ice formed again overnight on 23/24-Jan. After this date, most of the ice cover was obscured by snow. The ice cover slowly melted starting 20-Feb when the mean daily water temperature was above freezing at 0.16°C. On 27-Feb and 5-Mar the water level rose again, inundating the ice cover (Figure 7b). With the exception of skim ice forming adjacent to emergent boulders on cold nights, the site was intermittently clear of ice starting on 6-Apr and totally clear of ice from 17-Apr onwards.

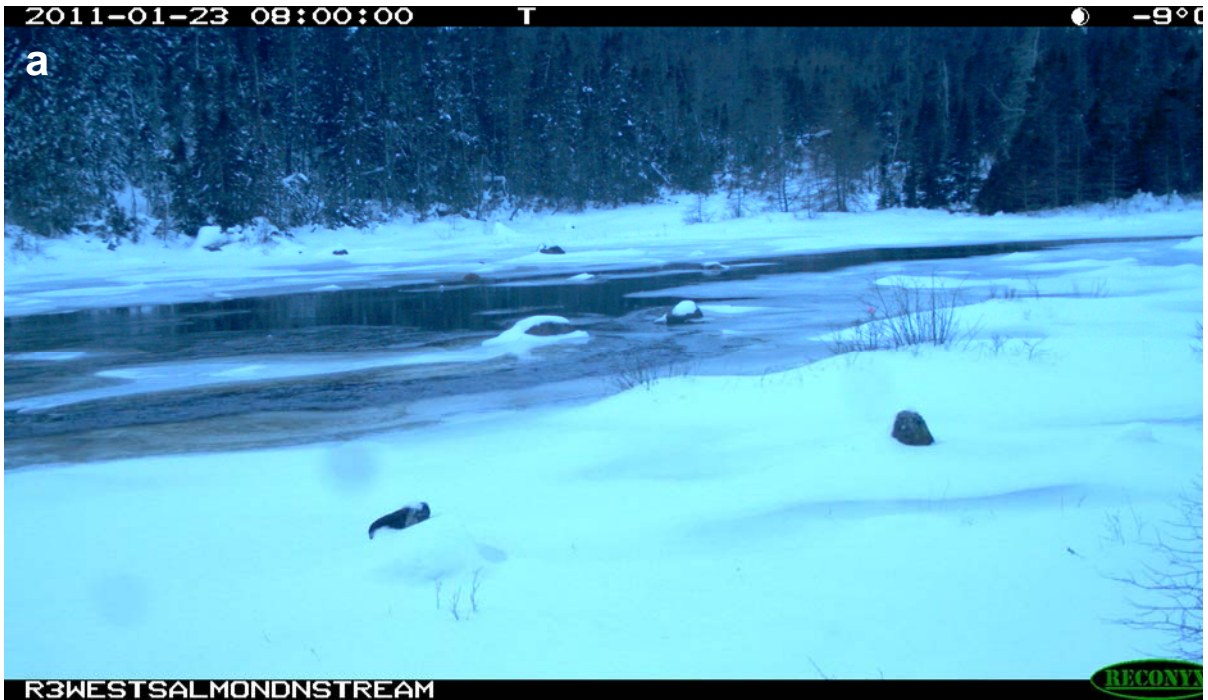
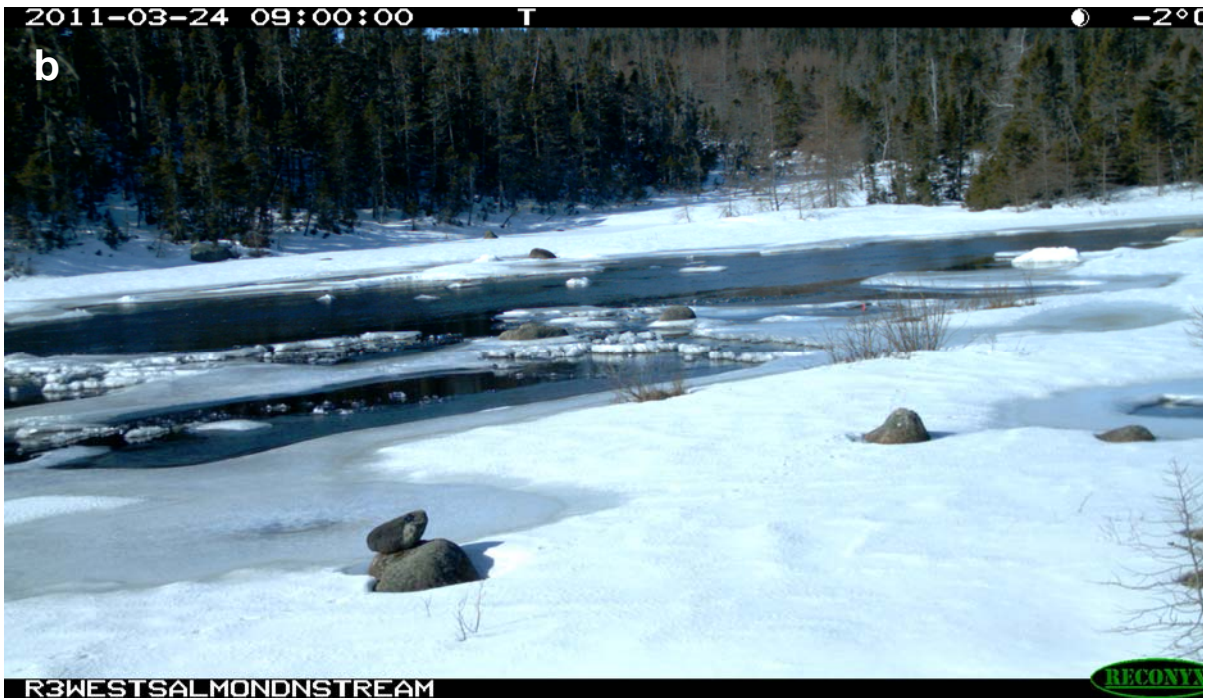
Figure 9. Ice observation photographs from the West Salmon River (regulated) downstream site taken by camera R3 showing: a) anchor ice on 23-Jan-11; and b) broken ice in the channel on 24-Mar-11.

Grassed bars were present in the channel at the West Salmon downstream site, which was wider (~60 to 75 m), shallower, and had fewer boulders than the upstream site. Ice conditions observed at this site are summarized in Figure 8 and were similar to those observed at the upstream site. However, skim ice and small amounts of anchor ice were observed downstream before they were observed upstream. Two anchor ice formation events occurred on 17/18-Jan and 23/24-Jan (Figure 9a), the same dates as those observed at the upstream site. After this time, the stream remained almost entirely ice-covered until ice melt began in early March. Broken pieces of ice were observed at the site on 15-Mar and 24-Mar (Figure 9b). These pieces moved through the site over the course of the day. The site was permanently ice free on 14-Apr.

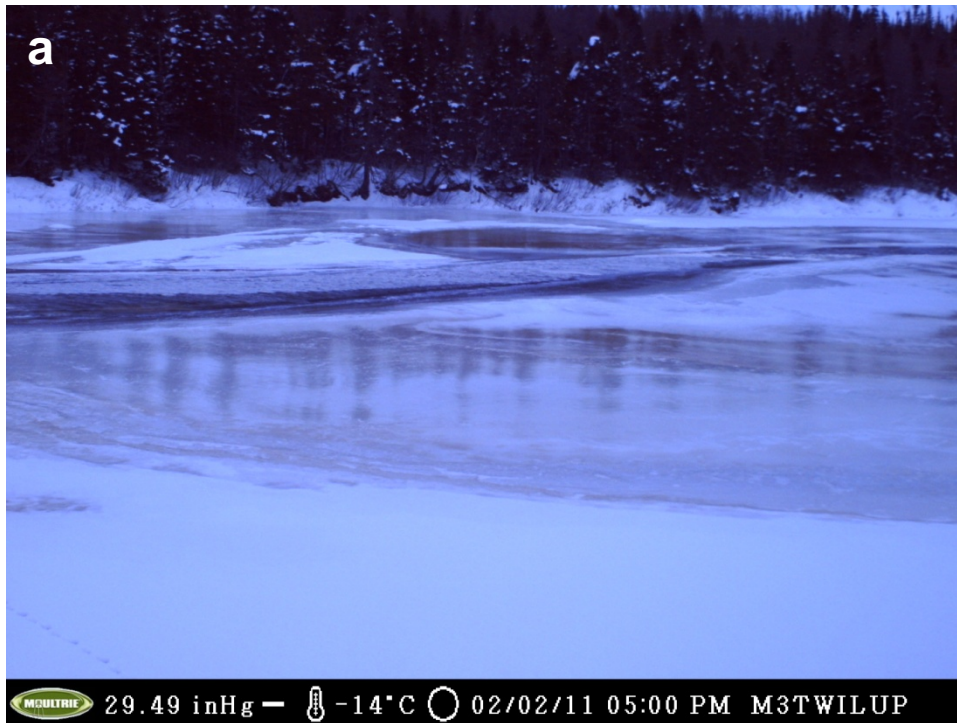
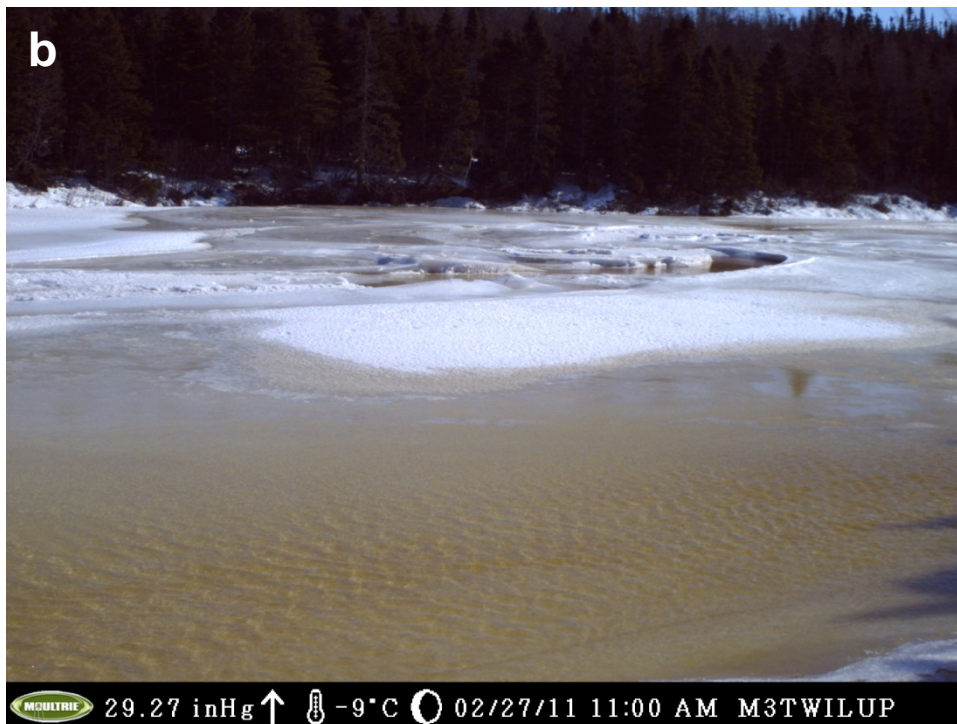
Figure 11. Ice observation photographs from Twillick Brook (unregulated) upstream site taken by camera M3 showing: a) frazil ice filling in an ice cover on 2-Feb-11 and; b) ice inundated by high water levels on 27-Feb-11.

The upstream study site on Twillick Brook was a 40 to 50 m wide, wadeable stream. The observed reach consisted of a pool and a riffle, with a small, frequently submerged grassed bar adjacent to the riffle. One camera at this site was the one that was improperly programmed (and thus did not take any ice photos), while the other was one of the Moultrie cameras that stopped before the memory card was full (and thus took photos only until 12-Mar), prior to breakup. Ice conditions observed at this site are summarized in Figure 10. Freeze-up processes were dominated by the growth of thermal/border ice from the stream margins and from the edges of the bar. This occurred first on 21-Nov when mean daily air temperatures dropped to  $-3.9^{\circ}\text{C}$ , before melting and re-forming on 11-Dec (minimum daily air temperature:  $-9.1^{\circ}\text{C}$ ) and then re-melted. During each of these ice-forming events the measured water temperature dropped to  $\sim 0^{\circ}\text{C}$ . Permanent ice first formed when both border ice growth and frazil slush were observed on 6-Jan. Ice first covered the entire reach on 2-Feb when a freeze-up front passed by the observation camera and mean daily air temperatures reached  $-15.3^{\circ}\text{C}$  (Figure 11a). The water level rose in the stream, partially inundating the ice cover on 23 to 27-Jan, 1 to 3-Feb, and 27-Feb to 2-Mar (Figure 11b). Water temperatures remained at  $\sim 0^{\circ}\text{C}$  from 17-Jan to 16-Mar.

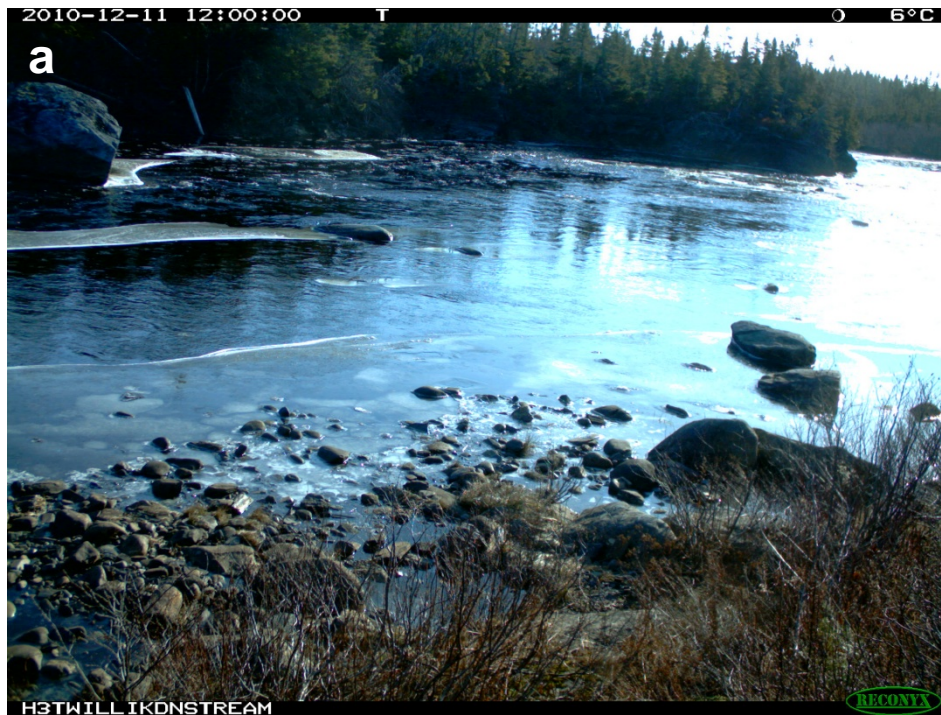
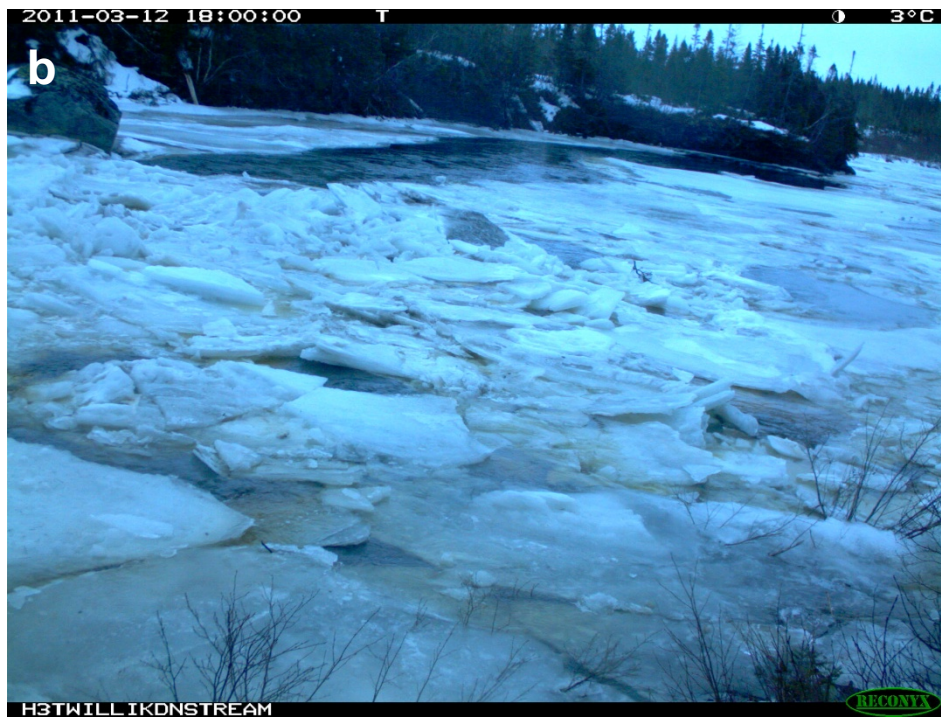
Figure 13. Ice observation photographs from Twillick Brook (unregulated) downstream site taken by camera H3 showing: a) partial ice cover on 11-Dec-10; and b) small ice jam on 12-Mar-11.

The downstream study site on Twillick Brook was a 30 to 40 m wide, wadeable stream. The observed reach consisted of a pool and a riffle, with a few emergent boulders on the riffle and a very large bedrock remnant near the left bank. The bedrock banks at this site were high and steep. As Figure 12 illustrates, freeze-up processes were similar to those observed at the upstream site; however, anchor ice was observed in the fast portion of the riffle, while no anchor ice was observed at the upstream site. Similar to the upstream site, freeze-up processes began with thermal ice growth and frazil activity on two separate occasions: 21-Nov and 11-Dec (Figure 13a) before the ice retreated and completely melted. Permanent ice growth also began on 6-Jan and was dominated by thermal ice growth, some frazil activity and anchor ice on the riffle. This reach did not entirely freeze over, as an open lead was present all winter. Breakup began 25-Feb when the rapids upstream of the site appeared to open up and mean daily air temperatures reached  $-2.6^{\circ}\text{C}$ . Broken ice moved into the reach and over the top of the intact ice at the study site. The permanent ice at the study reach began to breakup 8-Mar, while mean daily air temperature first reached above  $\sim 0^{\circ}\text{C}$  the day before on 7-Mar. This culminated in a small ice jam (Figure 13b) which was most pronounced on 13-Mar and then slowly cleared downstream over the next several days. Following the clearing of the winter ice from the reach, border ice formed at the channel margins and floating frazil slush formed a floating cover over the small open central portion. Anchor ice was again observed at the riffle at this time. The channel was first completely ice free on 31-Mar and permanently ice free 6-Apr.

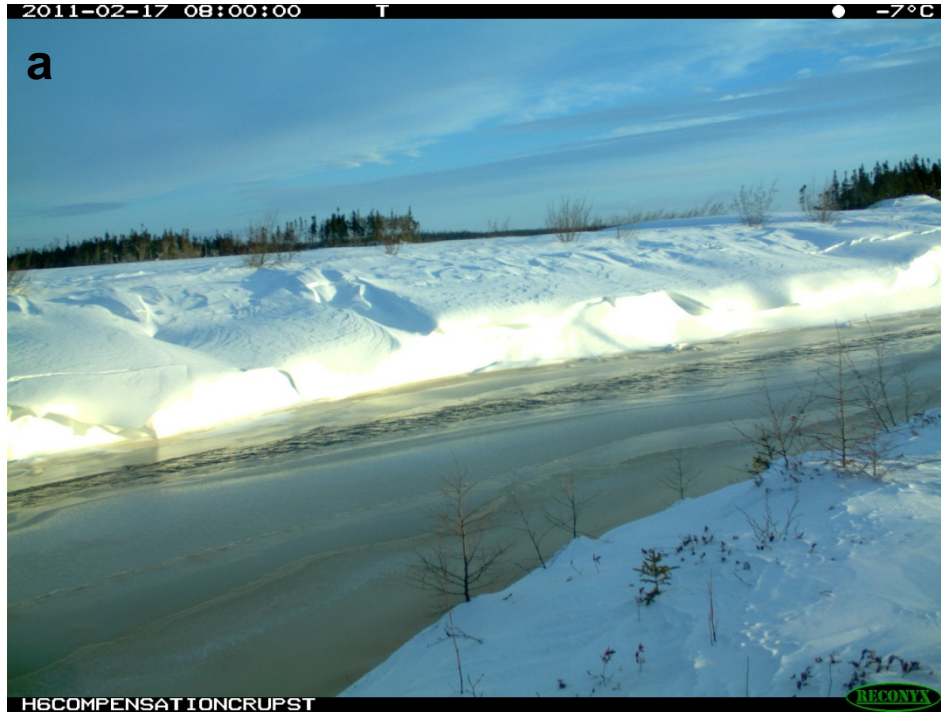
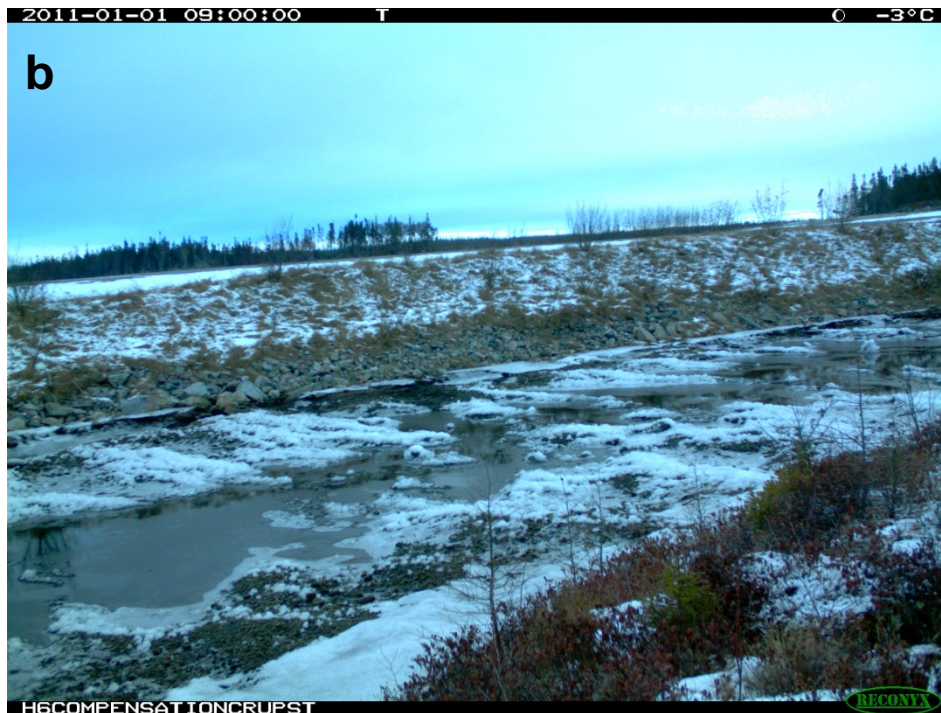
Figure 17. Ice observation photographs from Compensation Creek (regulated) upstream site taken by camera H6 showing: a) ice cover on 17-Feb-11 and; b) low water condition on 1-Jan-11.

The upstream study reach on Compensation Creek was a ~15 m wide pool section at the apex of a bend. As Figure 16 illustrates, the freeze-up processes at this site were dominated by thermal border ice growth. The first ice growth occurred as skim ice at the channel margins on 21-Nov when mean daily air temperatures dropped to  $-3.1^{\circ}\text{C}$ . This skim ice formed, melted and reformed repeatedly until 5-Jan, when the first permanent ice formed. This ice gradually advanced and retreated over the course of the season, with a maximum of 90% border ice coverage (Figure 17a) on 17/18-Feb when mean daily air temperatures dropped to  $-8.6^{\circ}\text{C}$ . The ice slowly melted until the first ice-free day 13-Apr. There were two events on the mornings of 1-Jan and 2-Jan where the water level dropped so significantly that much of the channel bed was exposed (Figure 17b).

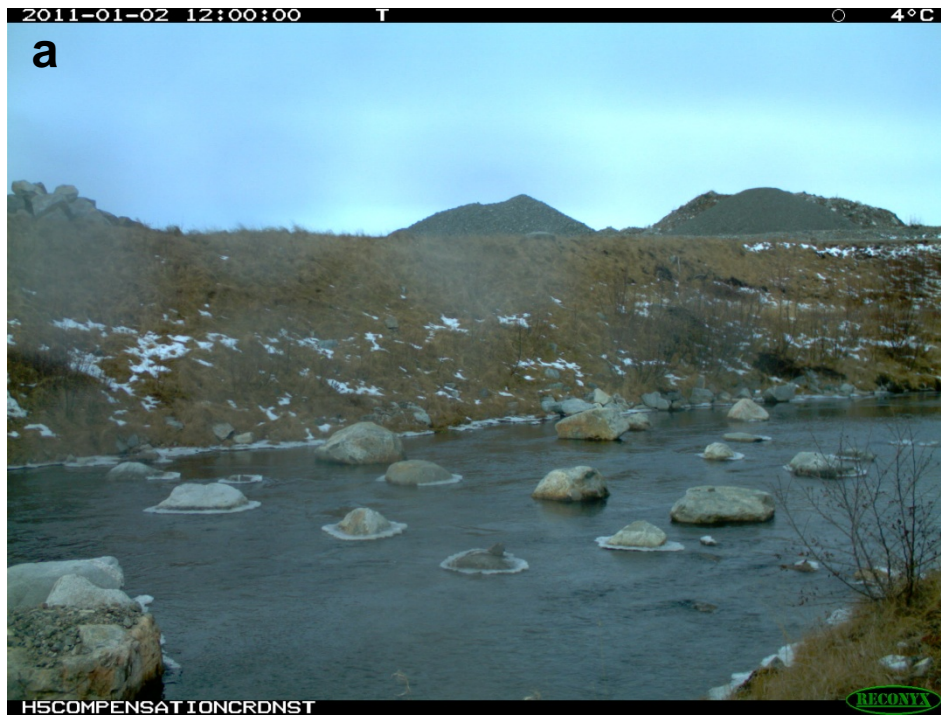
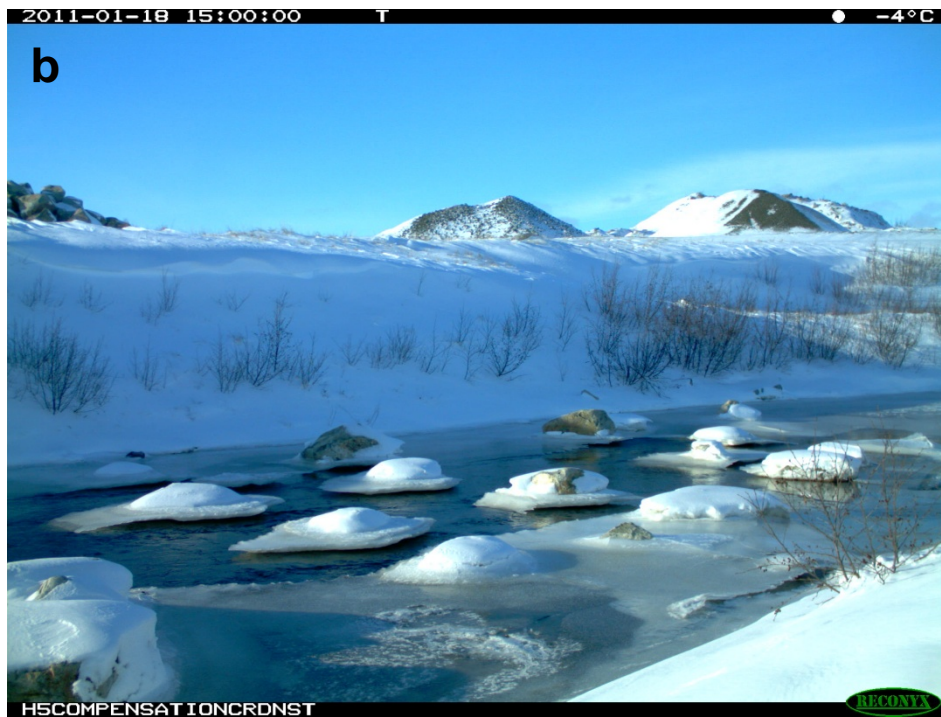
Figure 19. Ice observation photographs from Compensation Creek (regulated) downstream site taken by camera H5 showing: a) ice cover advancing from boulders and stream margins on 2-Jan-11; and b) ice shelves on 18-Jan-11.

The downstream study reach on Compensation Creek (regulated) was a ~15 m wide reach at the downstream end of a bend with emergent boulders. As Figure 18 illustrates, the freeze-up processes at this site were similar to those at the upstream reach in that they were dominated by thermal ice growth. However, unlike the upstream reach, a complete ice cover formed here. The ice cover first began to form at the channel margins as well as at the boundaries of the emergent boulders 22-Nov when mean daily temperatures dropped to  $-3^{\circ}\text{C}$ . This ice cover melted before reforming briefly on 12-Dec when mean daily temperatures dropped to  $-6.7^{\circ}\text{C}$ . There were two events on the mornings of 1-Jan and 2-Jan where the water level dropped so significantly that much of the channel bed was exposed. The first permanent ice began to form 4-Jan, though no data exist for 5-Jan because of fog or frost on the camera lenses. This ice cover gradually advanced from the stream borders and the emergent boulders (Figure 19a). Broken ice was observed on 31-Jan when the water level dropped, exposing ice shelves attached to the boulders (e.g. Figure 19b), which cracked and collapsed. The thermal ice gradually retreated, with the first ice free day occurring 7-Mar and the channel permanently open from 29-Mar onward.

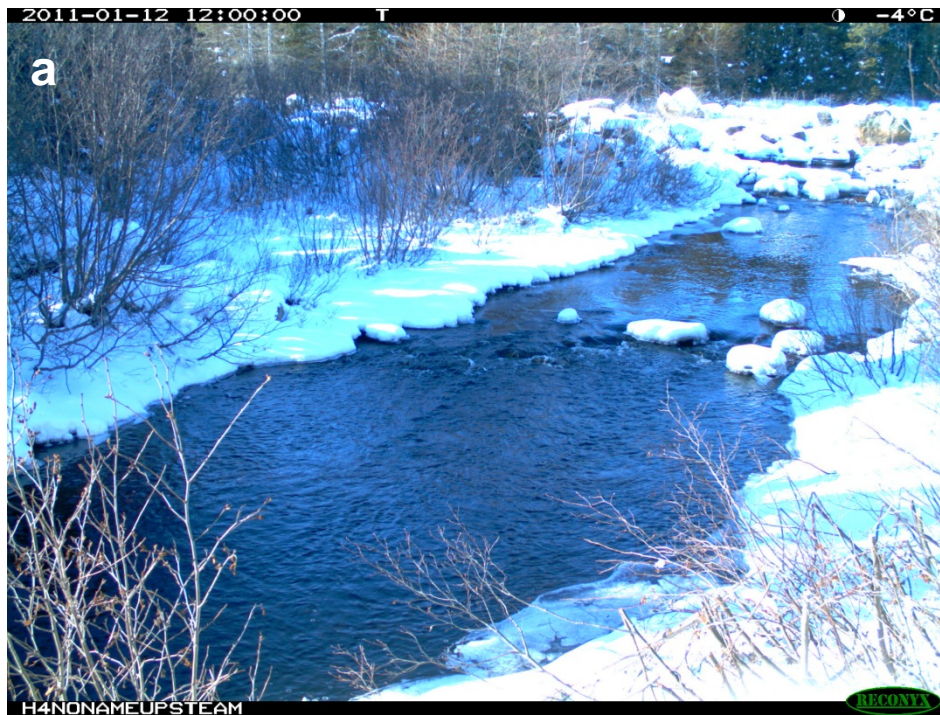
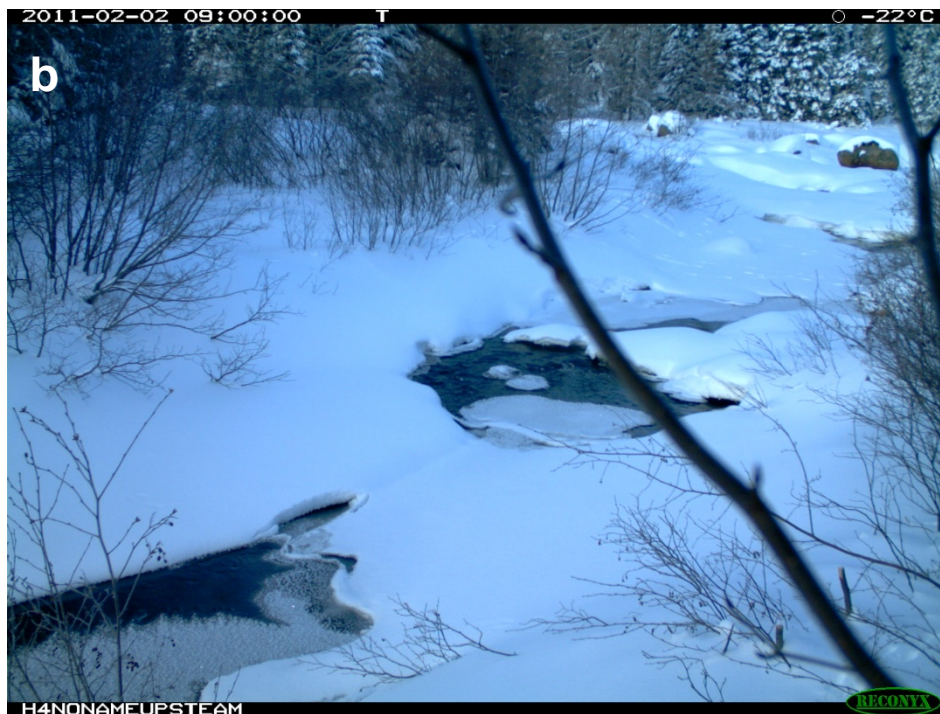
Figure 21. Ice observation photographs from the upstream site on the unnamed creek (unregulated) taken by camera H4 showing: a) first permanent ice on 12-Jan-11; and b) floating frazil on 2-Feb-11.

The upstream study reach on the unregulated unnamed creek was an ~8 m wide wadeable reach with step-pool morphology. Two pools and two steps were included in the observed area. As Figure 20 illustrates, freeze-up processes at this site were dominated by thermal ice growth on the pools and anchor ice growth on the exposed boulders at the steps. The first ice growth observed was on 15-Nov when skim ice formed at the margins of the pools. Thermal ice formed and melted periodically starting 22-Nov, 11-Dec, 27-Dec, 30-Dec, and 6-Jan, which are all periods when the mean daily temperature dropped to below  $0^{\circ}\text{C}$ . The first permanent ice 12-Jan (Figure 21a). In all instances, ice formed as thermal ice on the surface of the pools and anchor ice adjacent to the boulders in the stream. Floating frazil slush ice was observed 2-Feb and 3-Feb on the surface of the pools, stranded behind the frozen boulder steps (Figure 21b). The channel was 100% covered by ice for only 3 days from 12-Feb to 14-Feb, while much of the time, an open lead existed at the base of one of the steps. Breakup began when rising water levels inundated the ice cover on 26-Feb and 28-Feb, followed by ice cracking on 28-Feb. The reach then re-froze before being inundated again by rising water levels 8-Mar to 14-Mar, when the ice broke up and was cleared from the reach. Thermal ice began to reform 18-Mar when the

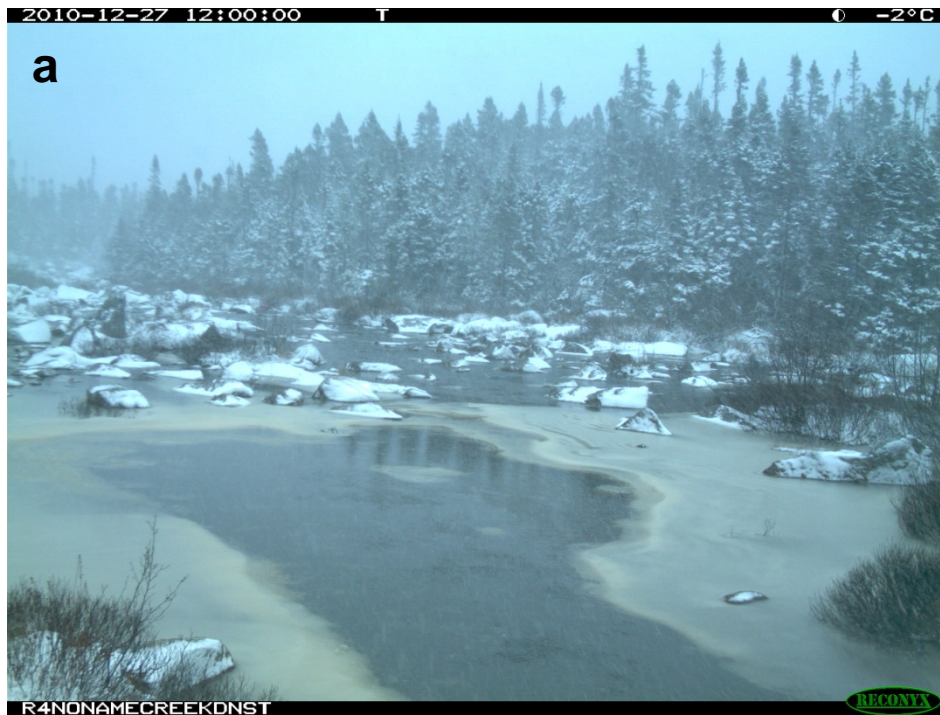
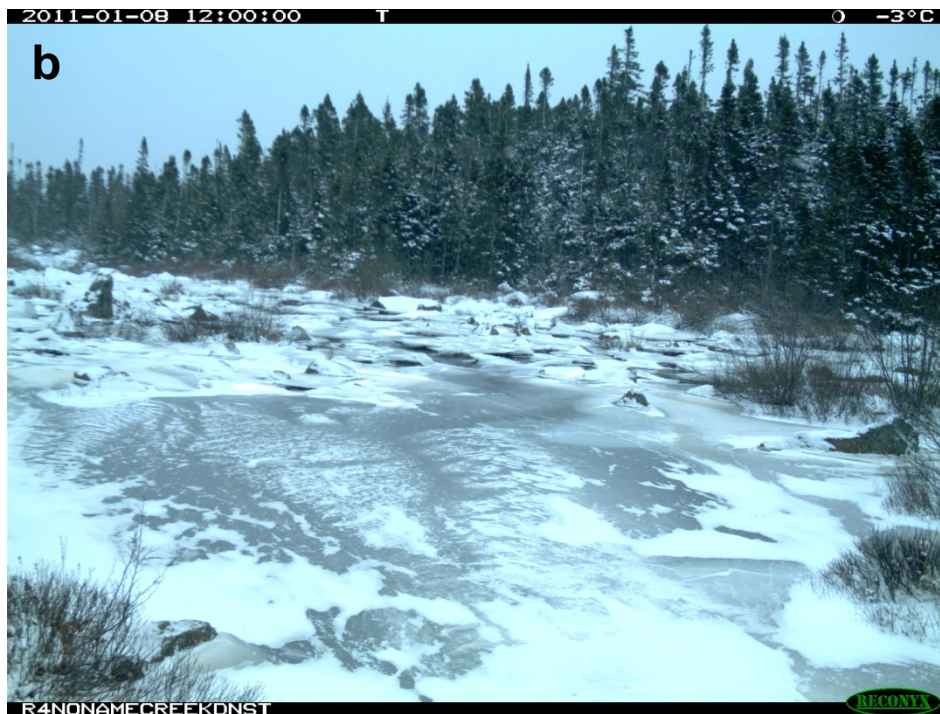
Figure 23. Ice observation photographs from the downstream site on the unnamed creek (unregulated) taken by camera R4 showing: a) anchor ice on 27-Dec-11; and b) ice cover on 8-Jan-11.

The downstream study reach on the unnamed creek was much wider than the upstream reach, consisting of a large pool upstream of an area with many large emergent boulders and an island with willows growing on it. As Figure 22 illustrates, freeze-up at this site involved many different ice processes. Skim ice first formed between the boulders and growing from pool margins on 16-Nov (mean daily air temperature: 2.5°C, daily minimum: -3.2°C). This ice melted and then skim ice and thermal ice formed 21-Nov, which melted by 3-Dec. Overnight 11/12-Dec (the coldest period in that month: mean daily air temperature -9.1°C) the channel was covered with thermal and floating frazil ice. During that night a frazil ice stopping front was observed passing by the view of the camera. This ice had melted by 16-Dec. Overnight on 26/27-Dec, anchor ice formed at the emergent boulders and the borders of the pool, forming a possible ice blockage on the camera side of the island (Figure 23a). The space upstream of the anchor ice then filled with floating frazil slush. The ice then melted out over the course of 28-Dec. Thermal border ice re-formed on 29-Dec and frazil ice filled the space between the border ice. The channel was completely covered by 8-Jan (Figure 23b). This ice cover stayed largely intact from 17-Jan to 5-Apr. On 6-Apr, water levels rose enough to inundate a portion of the ice cover. The ice then began to crack and broken ice was visible in the open sections of the stream starting 8-Apr. Most of the winter ice cleared out of the observed reach on 13-Apr. On 16-Apr, new border ice and frazil slush were observed, but melted within 1 day. The channel was permanently ice free on 18-Apr, after which mean daily temperatures below 0°C were observed only once more (22-Apr at -0.6°C).
